Trouble Shooting Guide for problems with drive cables

January 26, 2022

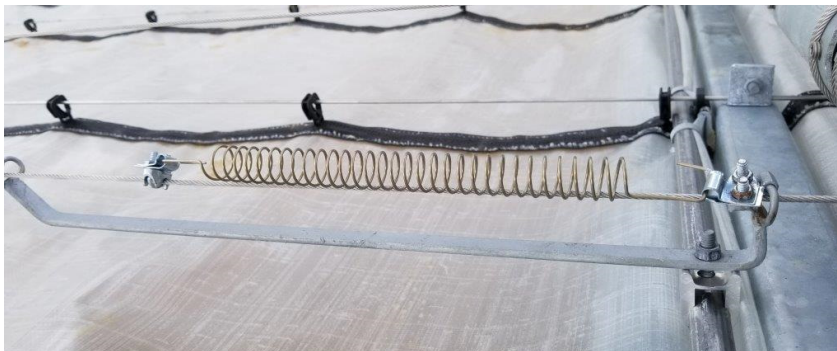
1. **Drive cable pretension is too low.** Cable pretension is the tension on the drive cable **without** any forces being exerted on the cable due to moving the roof in a retracted or closed position.
 - a. When the drive cable pretension is too low, the cable spring will collapse completely when the roof is fully retracted

Spring is extended when the roof is closed

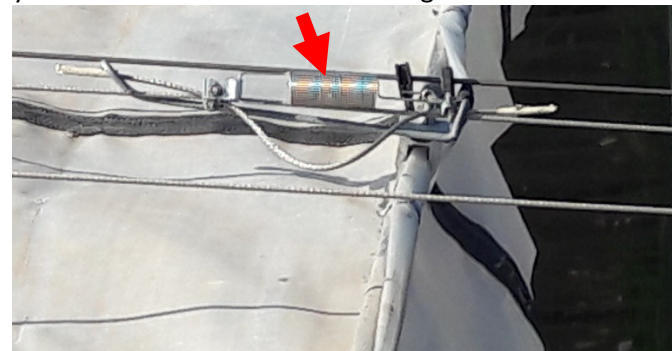
If the cable spring is fully collapsed when the roof is retracted, then there is a high risk of the drive cable to double wrap on the drive drum when the roof closes completely. When the drive cable double wraps, it usually results in the drive cable breaking.

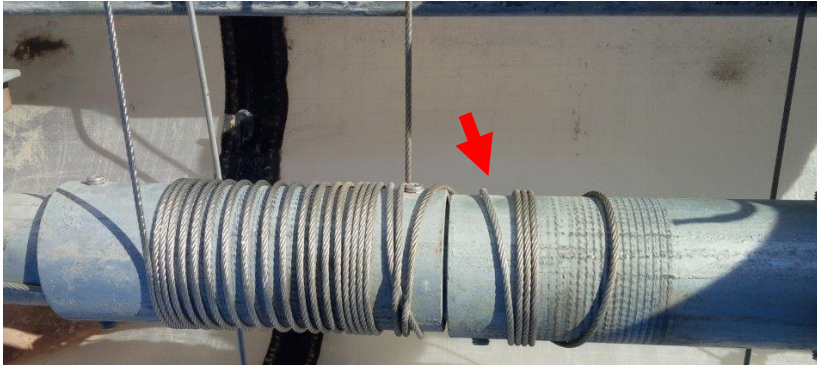
When the cable pretension is too low, then the cable spring can no longer maintain sufficient tension on the lower drive cable causing the lower drive cable to wrap on top of itself (double wrap)

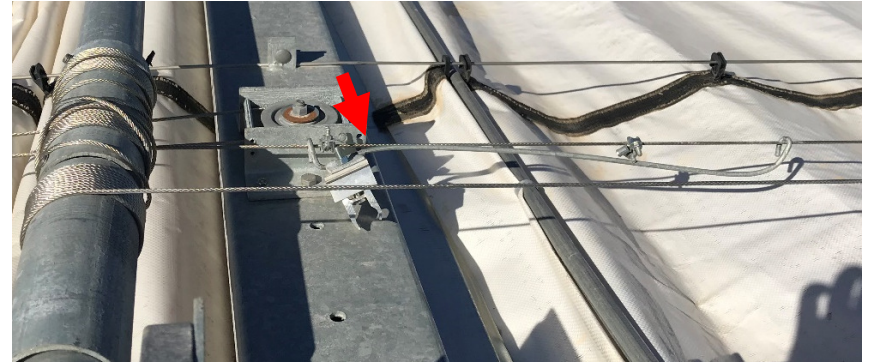
When the drive cable double wraps, it pulls the leading edge too far causing the delay bracket to become damaged, and the tube carrier to pop off the leading edge tubing. In severe cases, the cable will break.

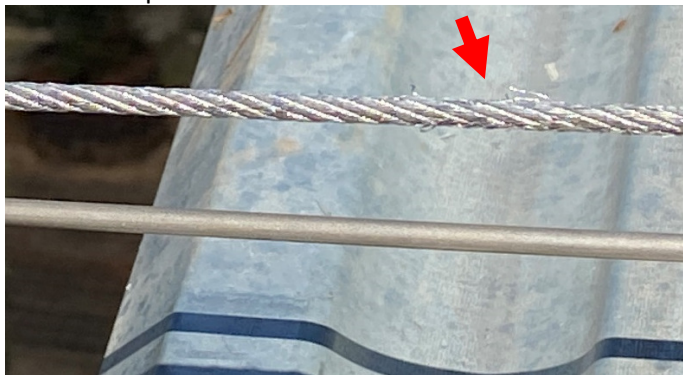
Excessive pretension will cause wearing of the drive cable where it wraps onto the drive drum

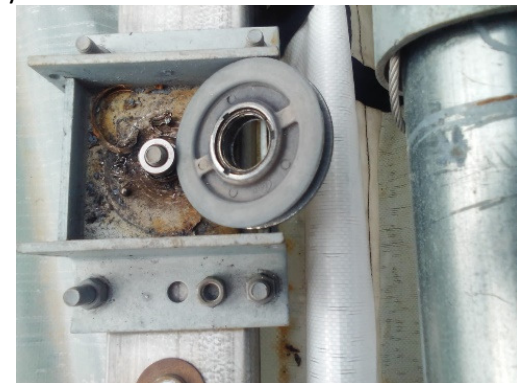
Excessive cable pretension will cause premature wear on the return pulley or bearing inside the pulley

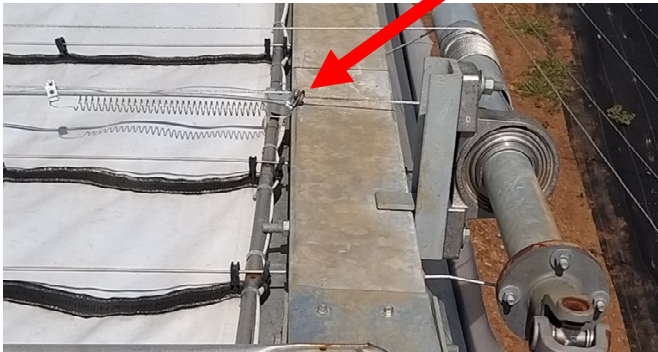
When the roof is in a fully covered position, if some delay brackets or tube carriers pull the leading edge tubing causing it to make contact with the truss or end member, then the tension in the drive cable between the delay bracket and the drive shaft exceeds the allowable limit causing some strands to break...eventually leading to the drive cable breaking.

Excessive cable tension causes damage to the cable where it begins to wrap onto the drive drum when the roof is in a fully closed position.

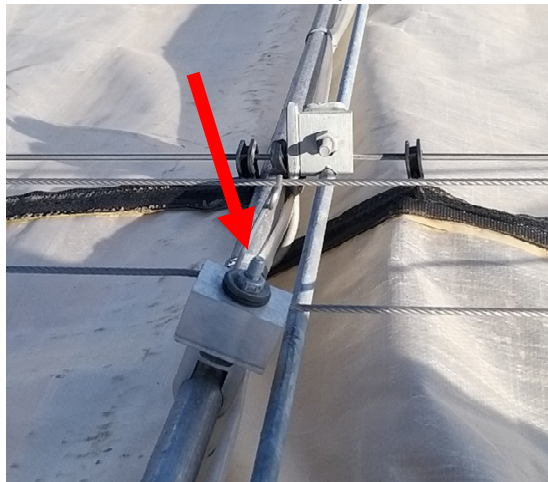
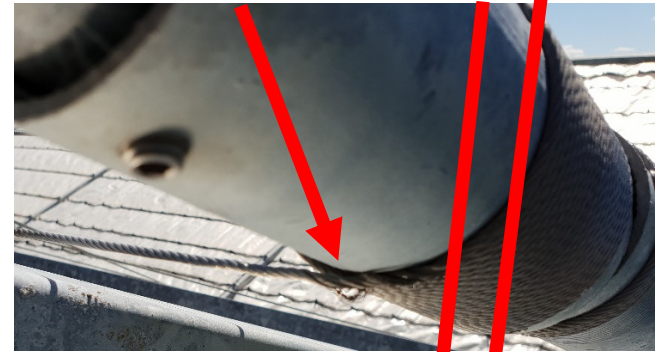
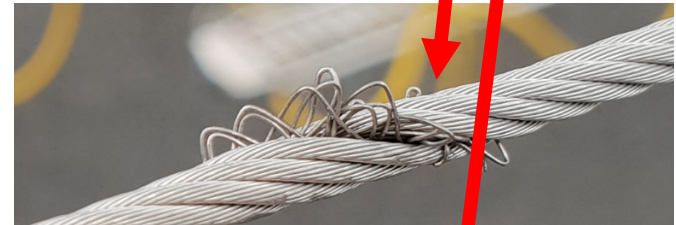
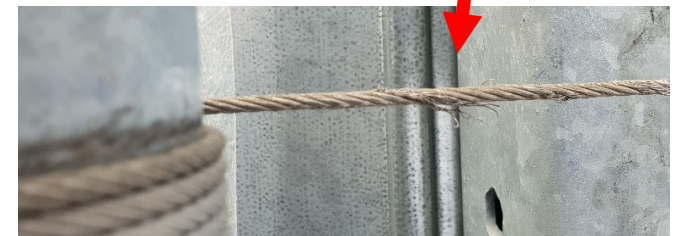
Tube carrier rotates when the leading edge has overtravelled causing cable tension dramatically increase

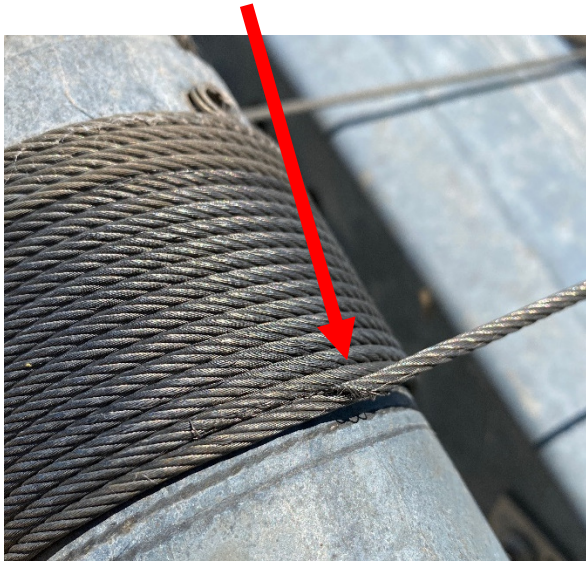
If the roof is over travelling when the roof is **retracted**, then the upper return cable will have excessive tension right where the cable begins to wrap on the drive drum causing cable strands to break.

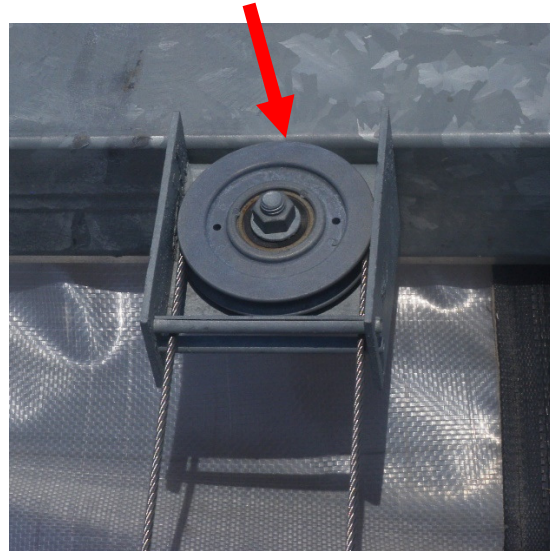
The cable tension will also become excessive where the cable goes around the pulley resulting in cable strands initially breaking with the cable eventually breaking completely if the excessive tension is not prevented

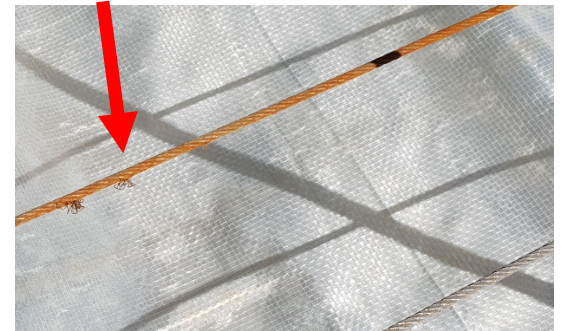
Broken strands due to excessive tension when the roof is fully retracted. Cables will rust if galvanized cables are used during a repair.

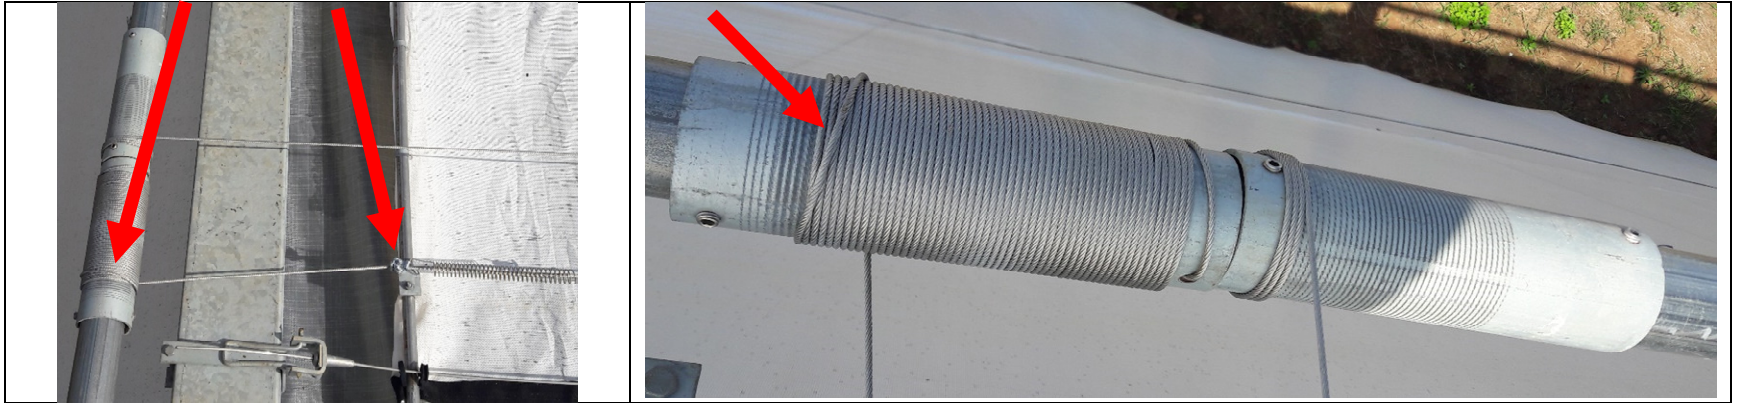
3. **Drive cables double wrapping on the drive drum** due to the delay brackets being secured to the leading edge such that the delay bracket is pulling the drive cable ovetop of the cable wraps already on the drum.

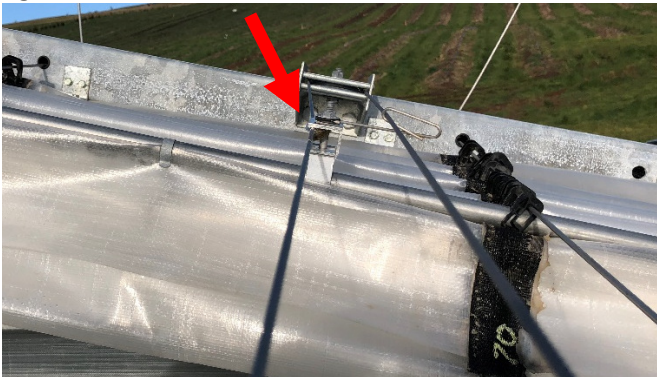
4. **Drive cables are not aligned with the return pulleys** due to the tube carriers being secured to the leading edge such that the tube carrier is pulling the drive cable on an angle to pulley.

Cable retainer is pulling the return cable against the pulley housing.

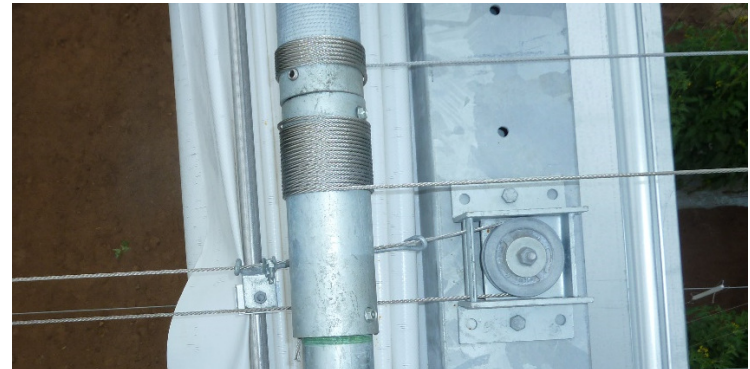
Delay bracket is misaligned causing friction between the delay bracket and the drive cable.
